West Virginia Chemical Leak
Etowah, Kanawha County, West Virginia
TDD No TL01-14-01-001

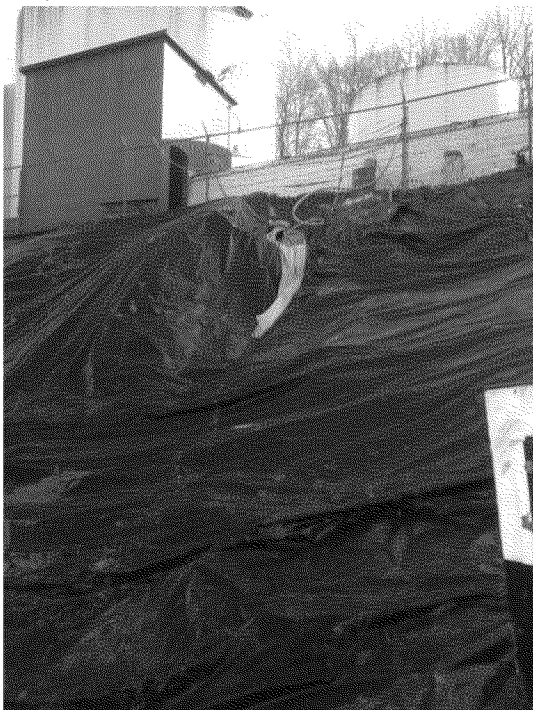
Photo No. IMG_1163; Taken on 01/17/14 at 10:49 hours by START GN. Water discharging from storm water culvert from under tank farm.

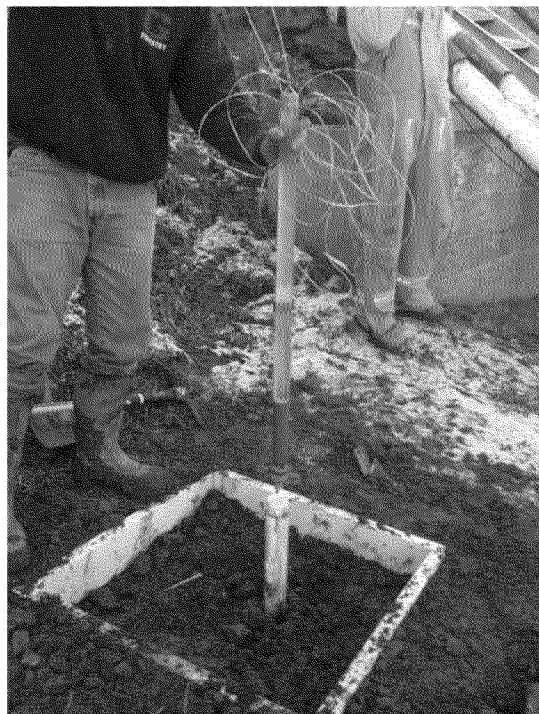
Photo No. IMG_1165; Taken on 01/17/14 at 11:00 hours by START GN. Bailer of groundwater retrieved from monitoring well MW-5.

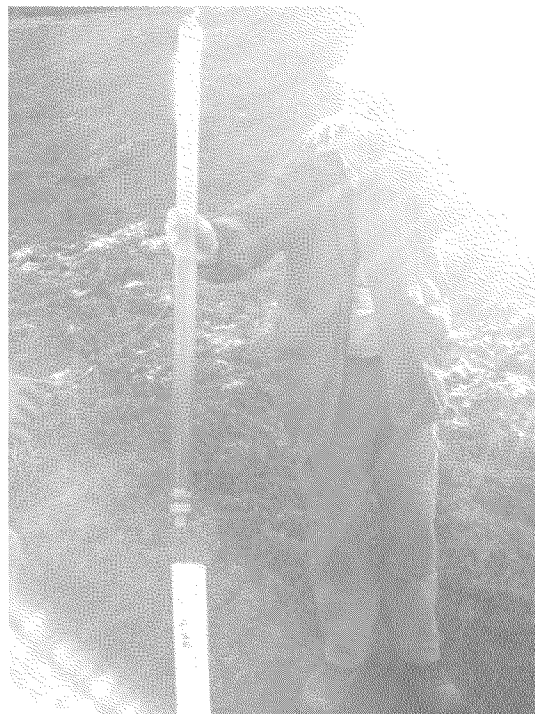
Photo No. IMG_1167; Taken on 01/17/14 at 11:00 hours by START GN. Bailer of groundwater retrieved from monitoring well MW-6.

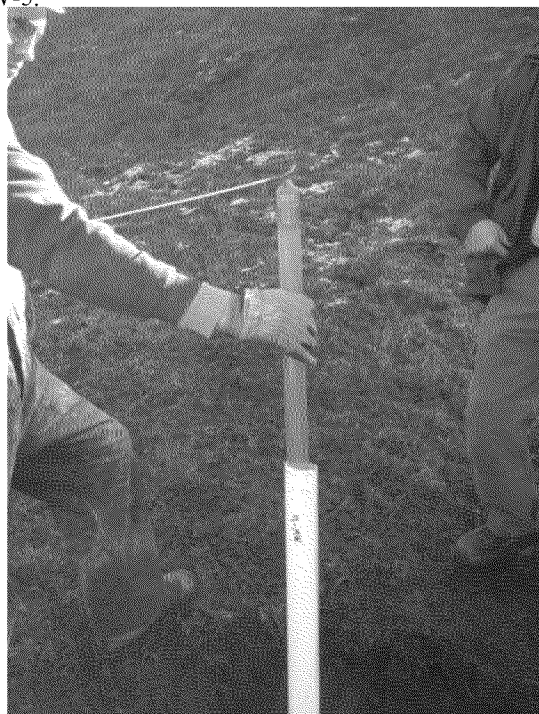
Photo No. IMG_1168; Taken on 01/17/14 at 11:38 hours by START GN. Bailer of groundwater retrieved from monitoring well MW-6.

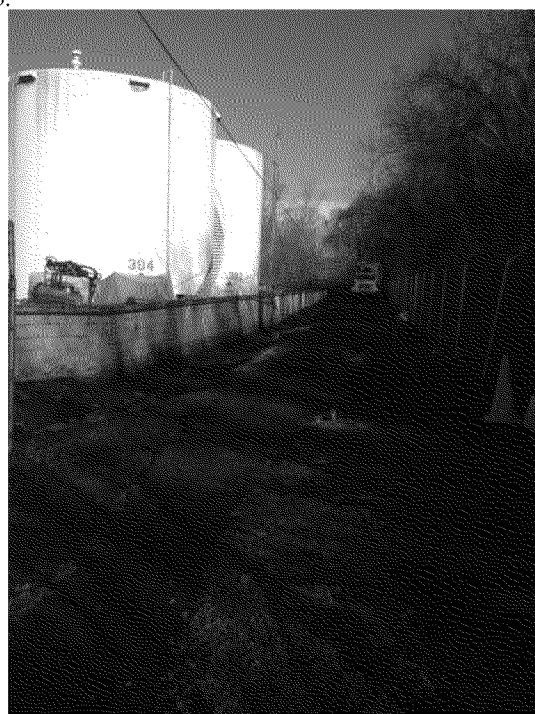
Photo No. IMG_1169; Taken on 01/17/14 at 11:38 hours by START GN. MW-7 in facility roadway on east side of tank farm.

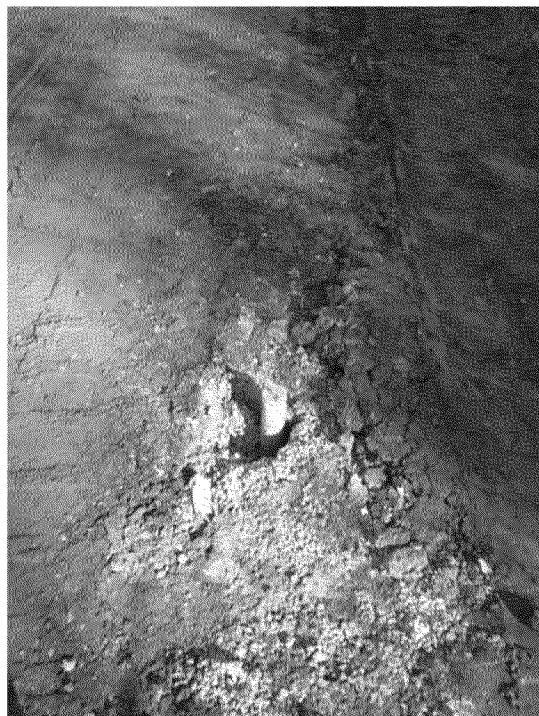
Photo No. IMG_1170; Taken on 01/17/14 at 11:39 hours by
START GN. MW-7 in facility roadway on east side of tank farm.

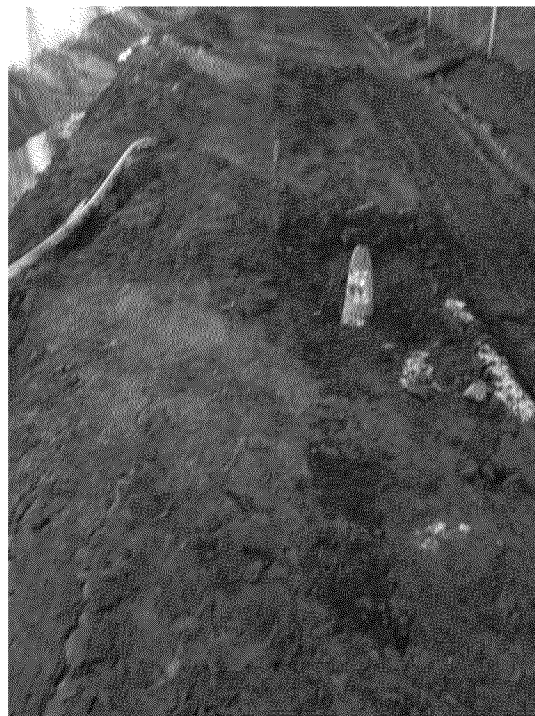
Photo No. IMG_1171; Taken on 01/17/14 at 11:41 hours by
START GN. MW-2 in facility roadway on east side of tank farm.

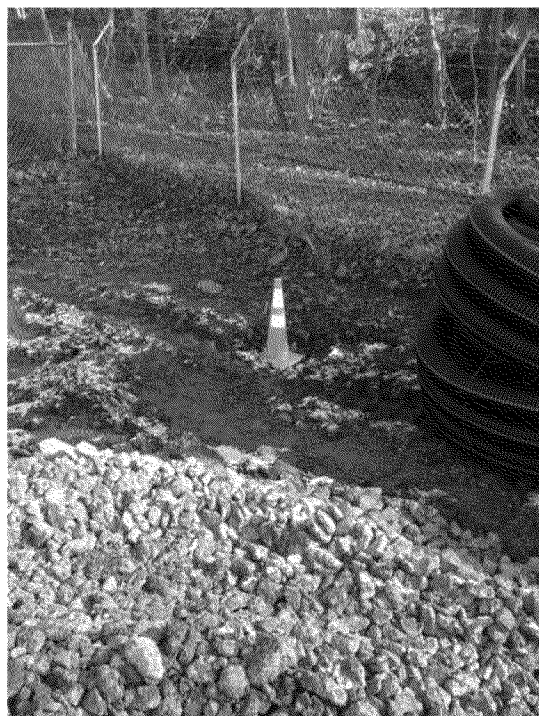
Photo No. IMG_1172; Taken on 01/17/14 at 11:42 hours by
START GN. MW-1 location in facility roadway on east side of
tank farm.

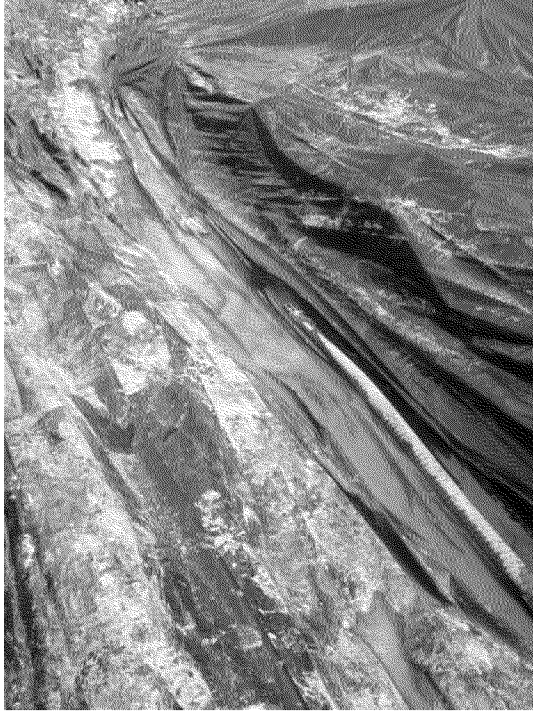
Photo No. IMG_1174; Taken on 01/17/14 at 12:30 hours by START GN. Pump intake in water collection trench/sump.

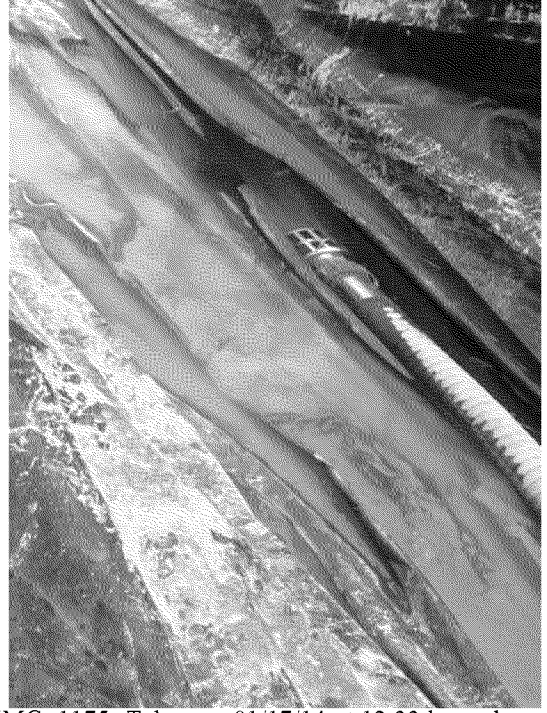
Photo No. IMG_1175; Taken on 01/17/14 at 12:33 hours by START GN. Product floating on surface of water in water collection trench/sump.

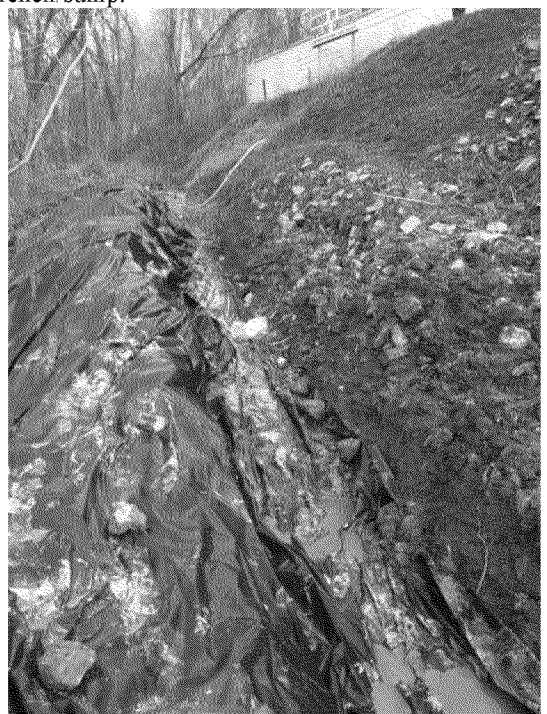
Photo No. IMG_1177; Taken on 01/17/14 at 14:24 hours by START GN. Northern end of water collection trench.

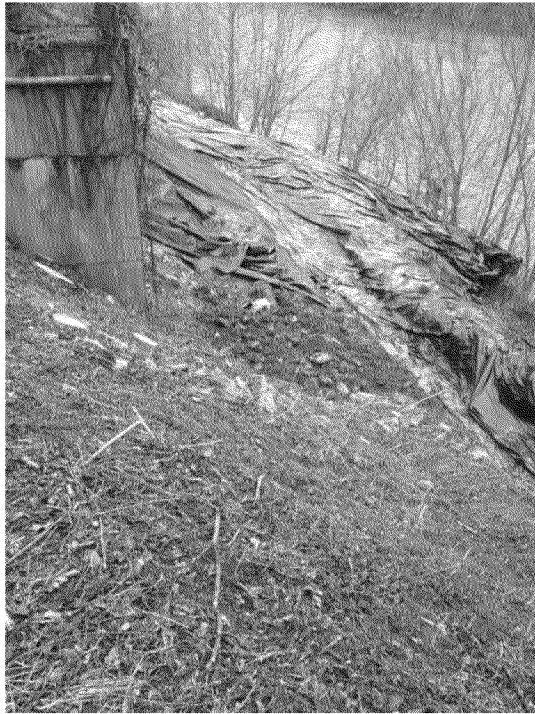
Photo No. IMG_1178; Taken on 01/17/14 at 14:24 hours by START GN. Disturbed soil above water collection trench.

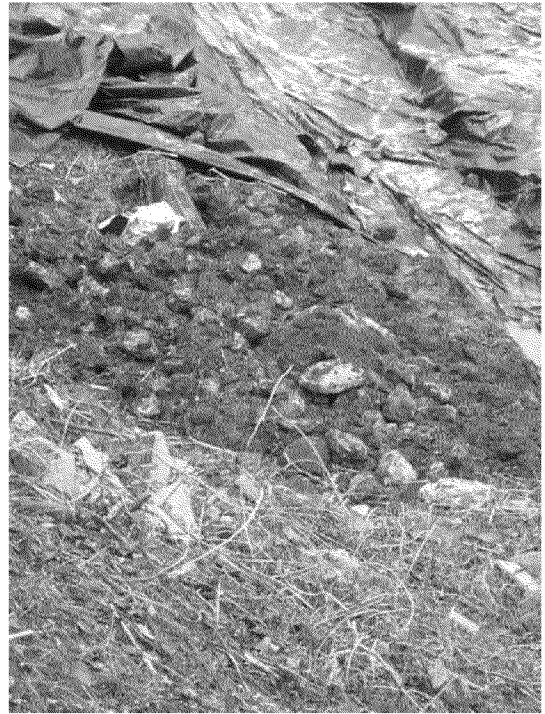
Photo No. IMG_1179; Taken on 01/17/14 at 14:36 hours by START GN. Disturbed soil above water collection trench.

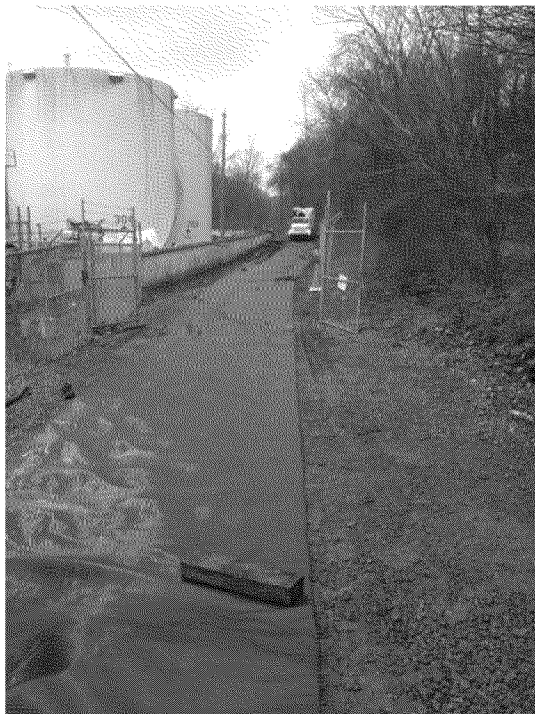
Photo No. IMG_1180; Taken on 01/17/14 at 15:10 hours by START GN. Geotextile fabric placed in roadway before gravelled.

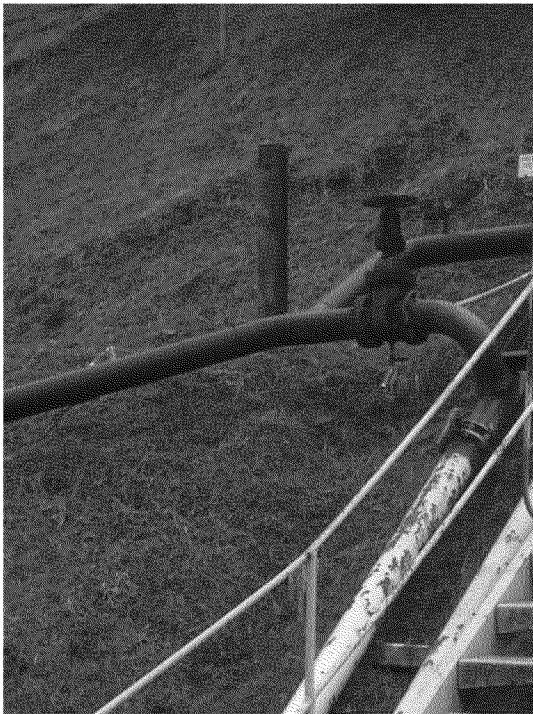
Photo No. IMG_1184; Taken on 01/17/14 at 15:31 hours by START GN. Steel casing installed for MW-5.

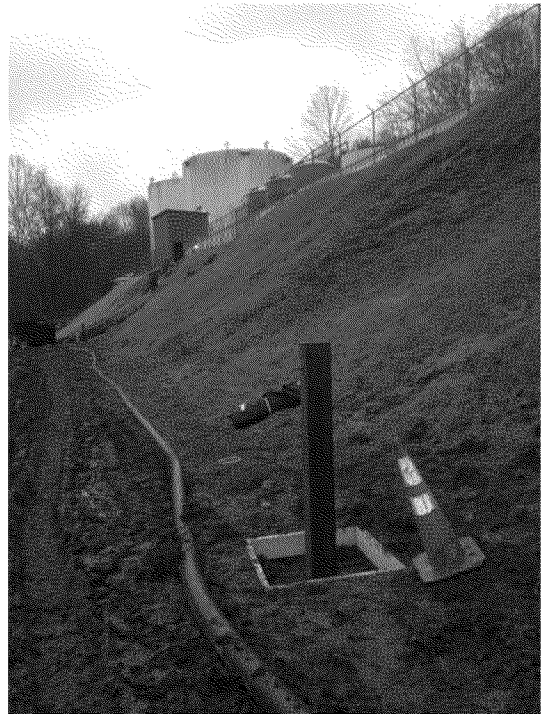
Photo No. IMG_1185; Taken on 01/17/14 at 15:33 hours by START GN. Steel casing installed for MW-4.

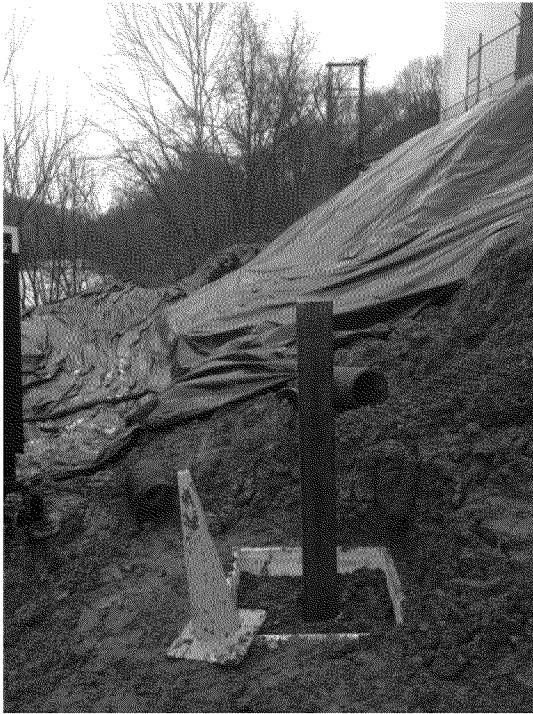
Photo No. IMG_1186; Taken on 01/17/14 at 10:58 hours by
START GN. Steel casing installed for MW-3.

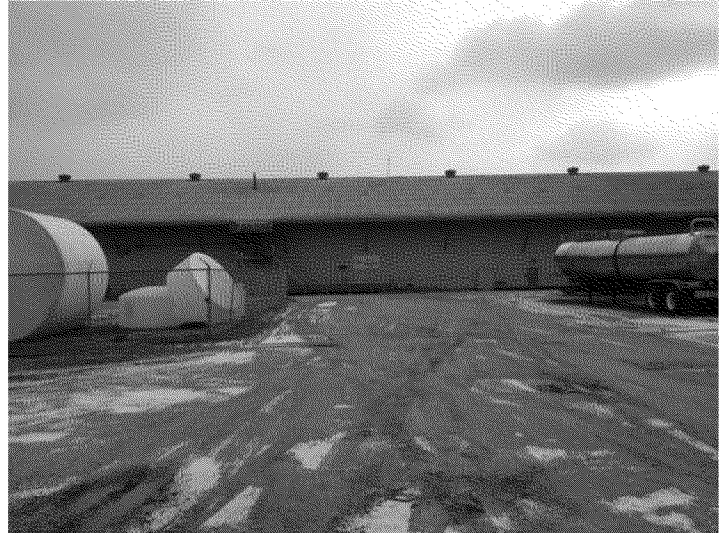
Photo No. IMG_1187; Taken on 01/18/14 at 10:58 hours by
START GN. Pocahontas Blending facility.

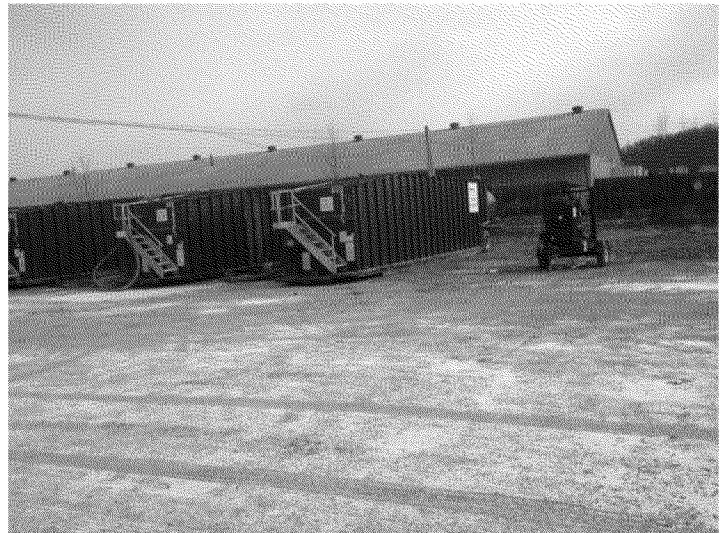
Photo No. IMG_1189; Taken on 01/18/14 at 11:03 hours by
START GN. Baker tanks leased by Freedom Industries staged at
Pocahontas Blending facility.

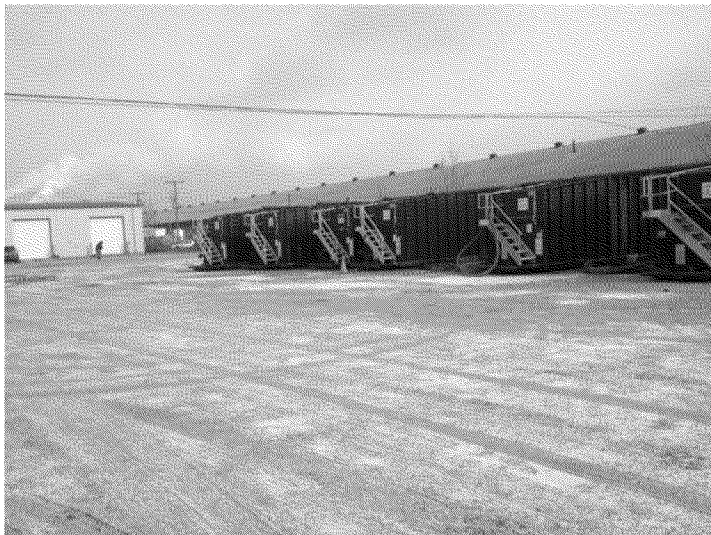
Photo No. IMG_1190; Taken on 01/18/14 at 11:04 hours by START GN. Baker tanks leased by Freedom Industries staged at Poca Blending facility.

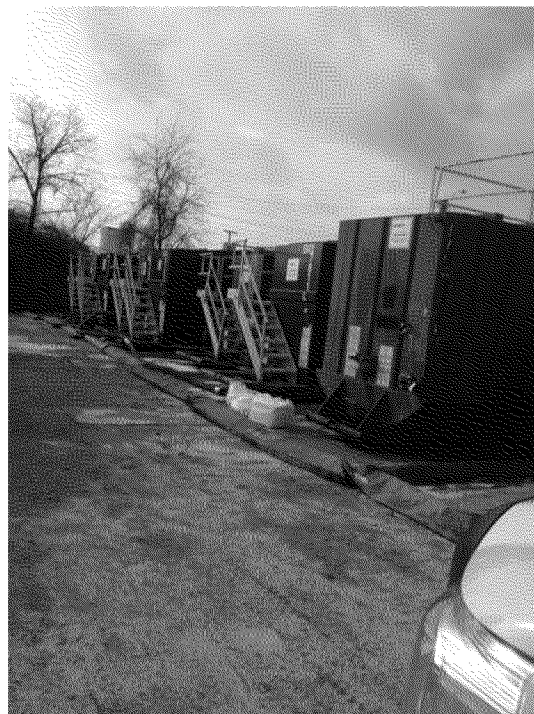
Photo No. IMG_1191; Taken on 01/18/14 at 11:04 hours by START GN. Baker tanks leased by Freedom Industries staged at Poca Blending facility.

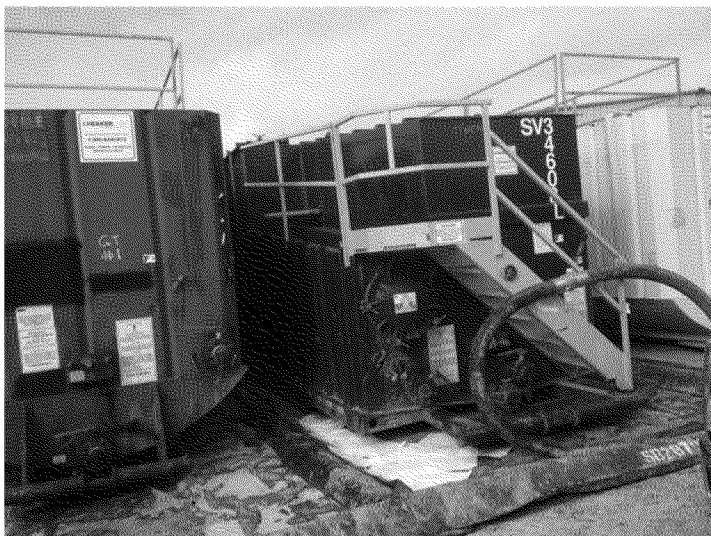
Photo No. IMG_1192; Taken on 01/18/14 at 11:04 hours by START GN. Baker tanks leased by Freedom Industries staged at Poca Blending facility.

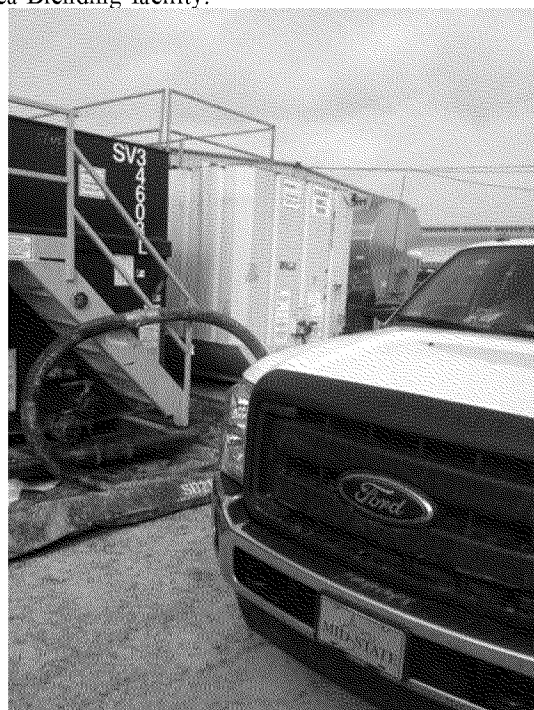
Photo No. IMG_1193; Taken on 01/18/14 at 11:06 hours by START GN. Baker tanks leased by Freedom Industries staged at Poca Blending facility.

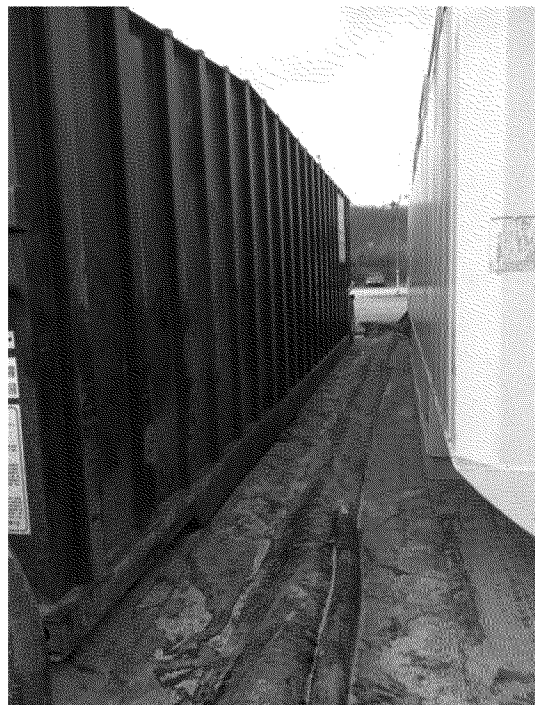
Photo No. IMG_1195; Taken on 01/18/14 at 11:06 hours by START GN. Baker tanks leased by Freedom Industries staged at Poca Blending facility.

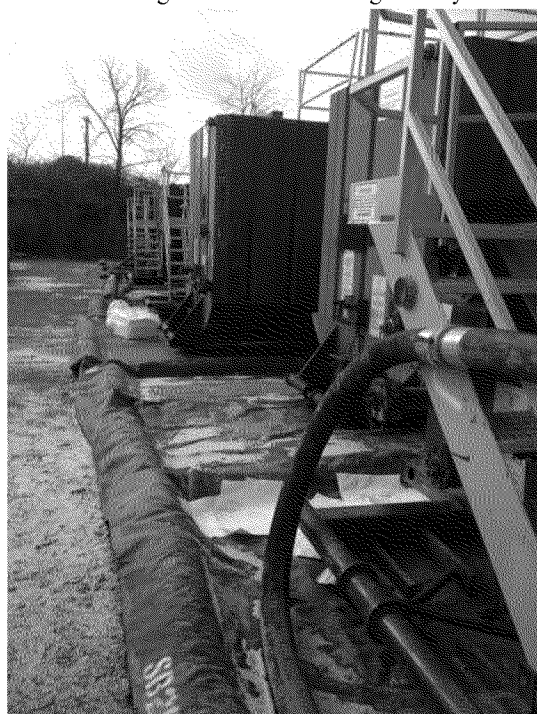
Photo No. IMG_1196; Taken on 01/18/14 at 11:06 hours by START GN. Baker tanks leased by Freedom Industries staged at Poca Blending facility.

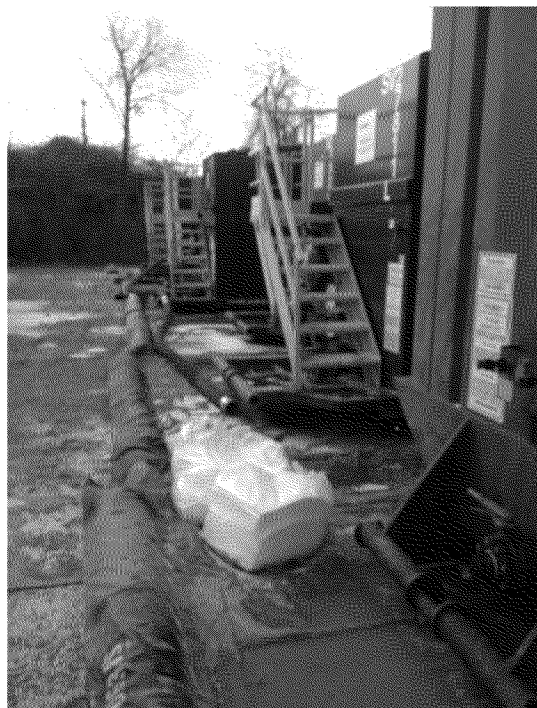
Photo No. IMG_1198; Taken on 01/18/14 at 11:07 hours by START GN. Baker tanks leased by Freedom Industries staged at Poca Blending facility.

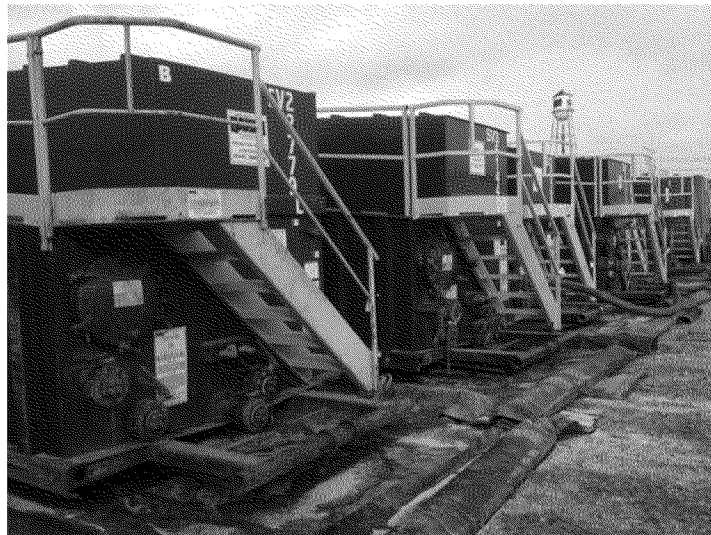
Photo No. IMG_1199; Taken on 01/18/14 at 12:00 hours by START GN. Baker tanks leased by Freedom Industries staged at Poca Blending facility.

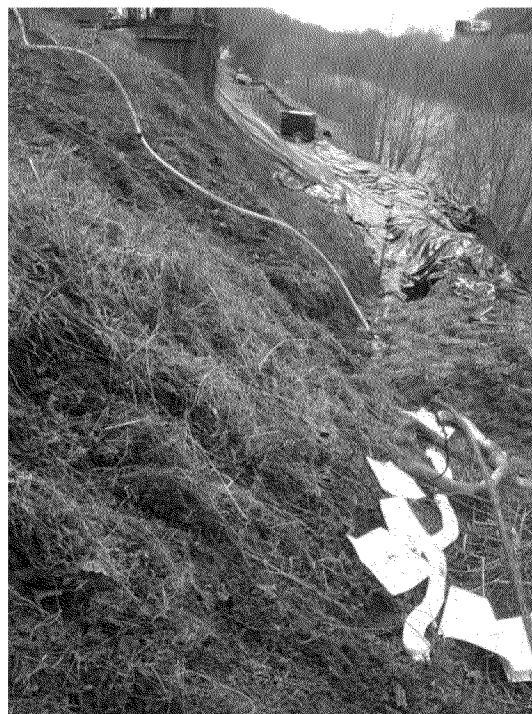
Photo No. IMG_1201; Taken on 01/18/14 at 12:15 hours by START GN. Seep area north of water collection trench.

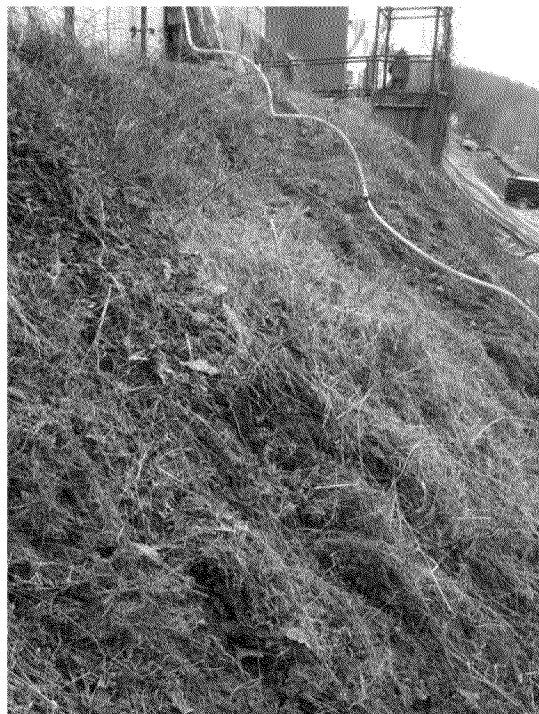
Photo No. IMG_1202; Taken on 01/18/14 at 12:16 hours by START GN. Hillside near reported original release area.

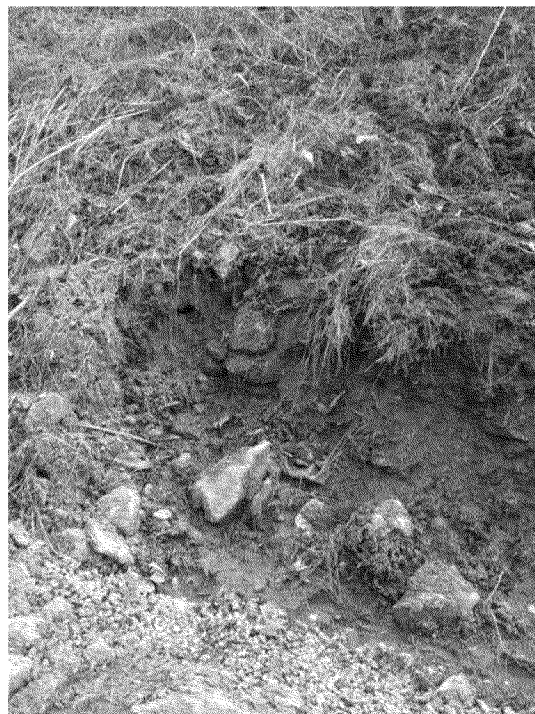
Photo No. IMG_1203; Taken on 01/18/14 at 12:17 hours by START GN. Water seeping out of hillside into trench.

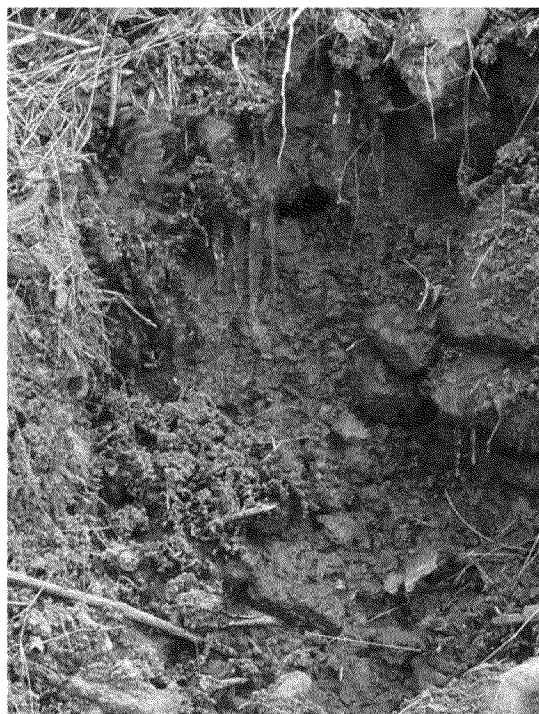
Photo No. IMG_1204; Taken on 01/18/14 at 12:21 hours by START GN. Water seeping out of hillside into trench.

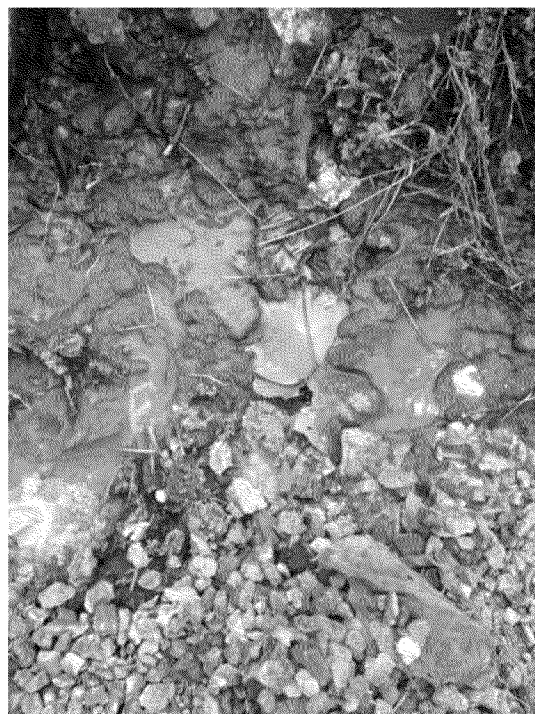
Photo No. IMG_1205; Taken on 01/18/14 at 10:56 hours by START GN. Water seeping out of hillside into trench.

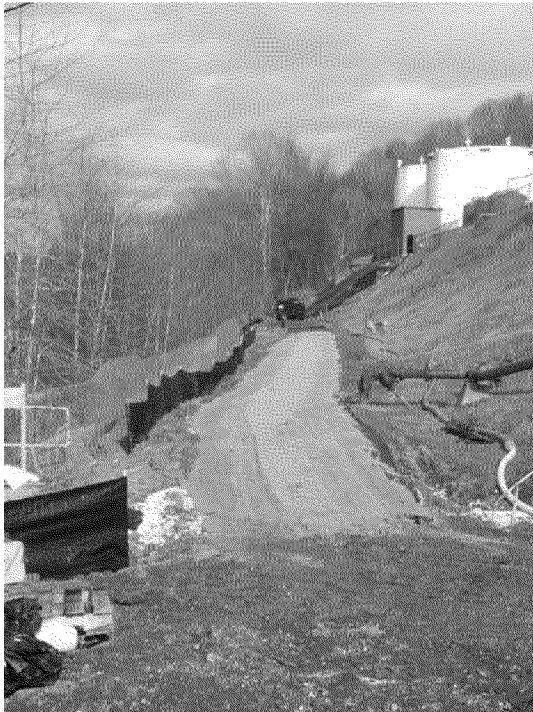
Photo No. IMG_1206, IMG_1207; Taken on 01/19/14 by START MD. The contractor excavated a and laid a road way along the river.

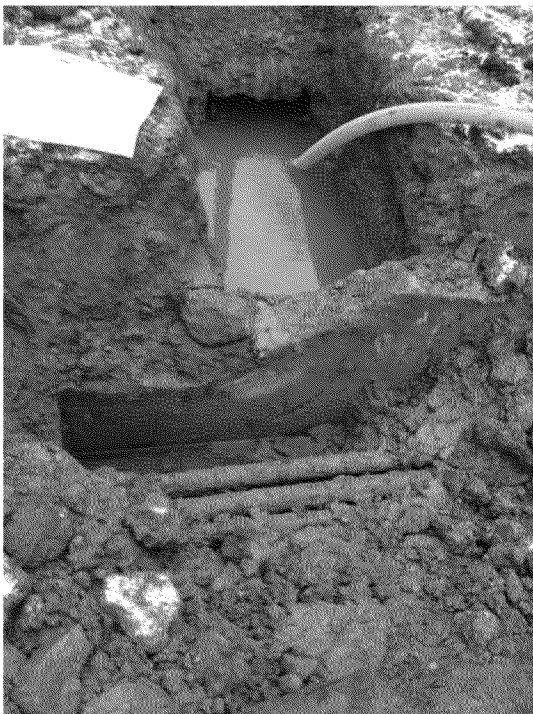
Photo No. IMG_1606; Taken on 01/19/14 at 11:00 hours by START MD. The contractor excavated a trench inside the wall of the containment area and discovered a compromised corrugated pipe that runs under the site.

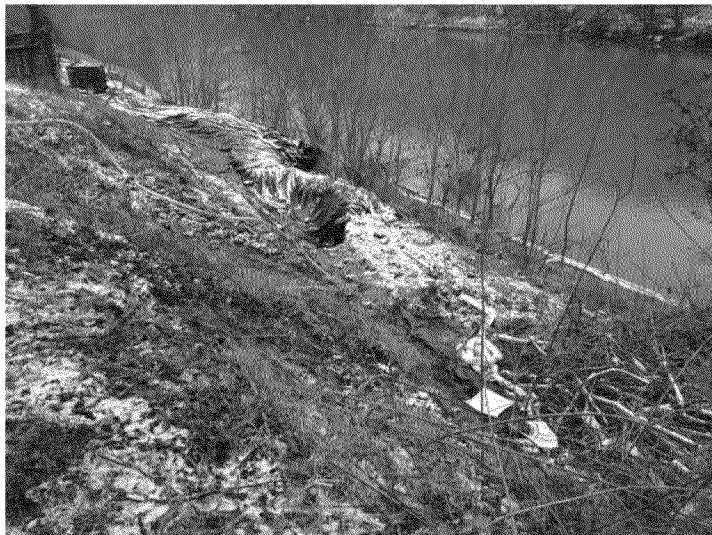
Photo No. IMG_1619; Taken on 01/19/14 at 11:16 hours by START MD. Standing at the corner of the containment wall, looking down at the Elk River, the trench is visible and has been extended to contain the newly discovered "seep."

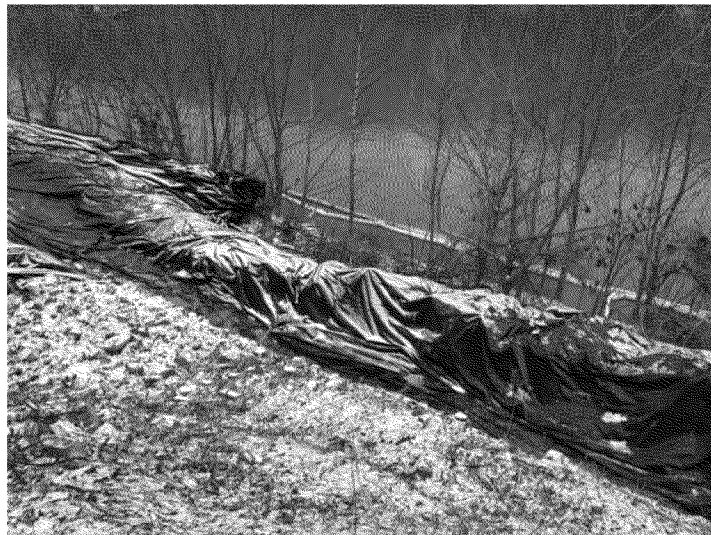
Photo No. IMG_1622; Taken on 01/19/14 at 11:16 hours by START MD. The trench at the northeastern end of the facility is currently successfully collecting the drainage from the containment area.

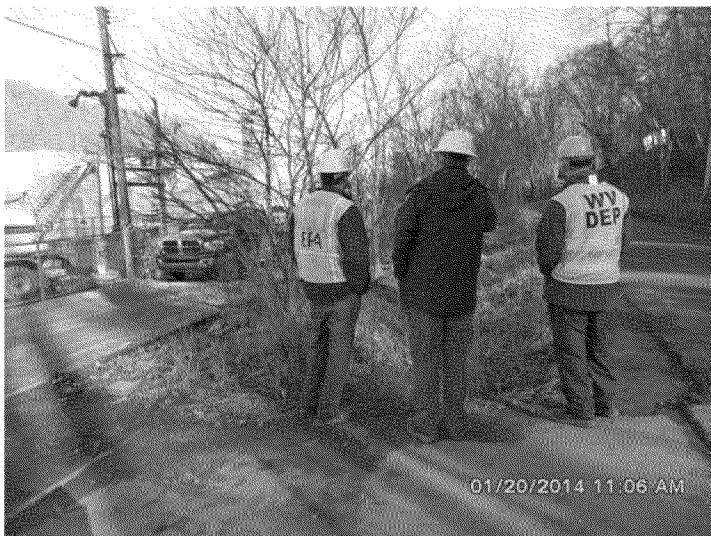
Photo No. SAM_1836; Taken on 01/20/14 at 11:10 hours by START MD. DEP, EPA, and facility representatives walk the trench along the site to determine the best direction to re-direct clean water from outside the site to avoid further contamination.

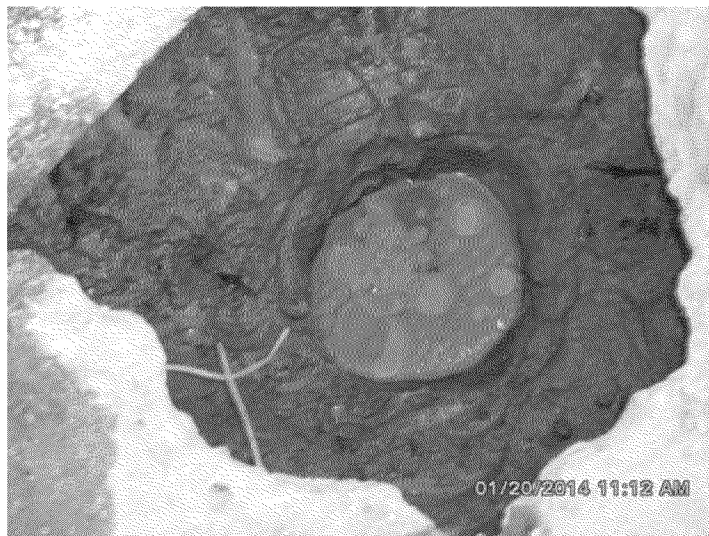
Photo No. SAM_1838; Taken on 01/20/14 at 11:15 hours by START MD. Product visible as a sheen on the water in one of the excavated holes.

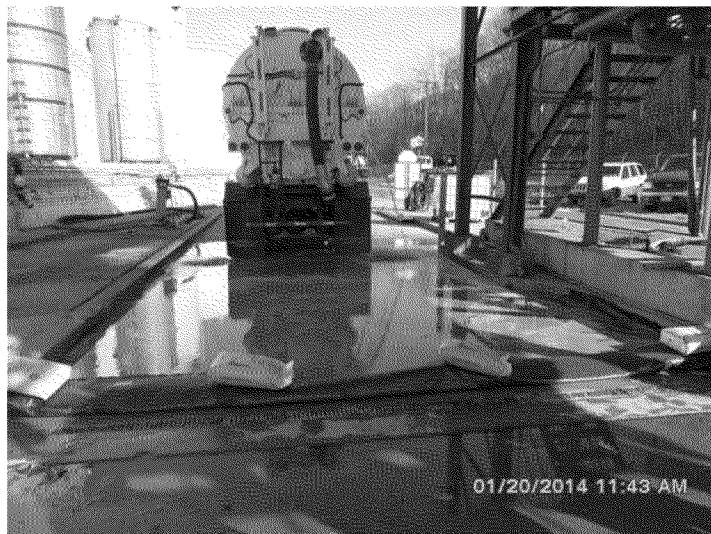
Photo No. SAM_1852; Taken on 01/20/14 at 11:14 hours by START MD. The barrier stops any soil from leaving the containment area. The water that enters the drain is directed to the oil-water separator.

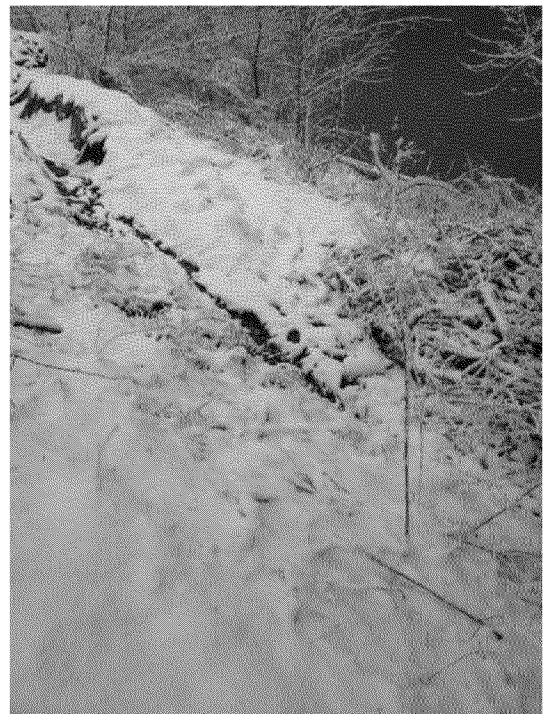
Photo No. IMG_1209; Taken on 01/21/14 at 11:17 hours by START GN. Extension of water collection trench to collect water from seep.

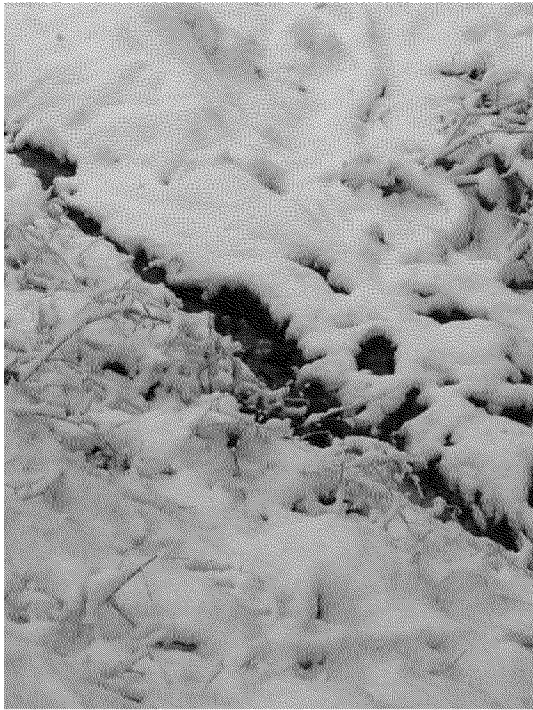
Photo No. IMG_1210; Taken on 01/21/14 at 14:03 hours by START GN. Extension of water collection trench to collect water from seep.

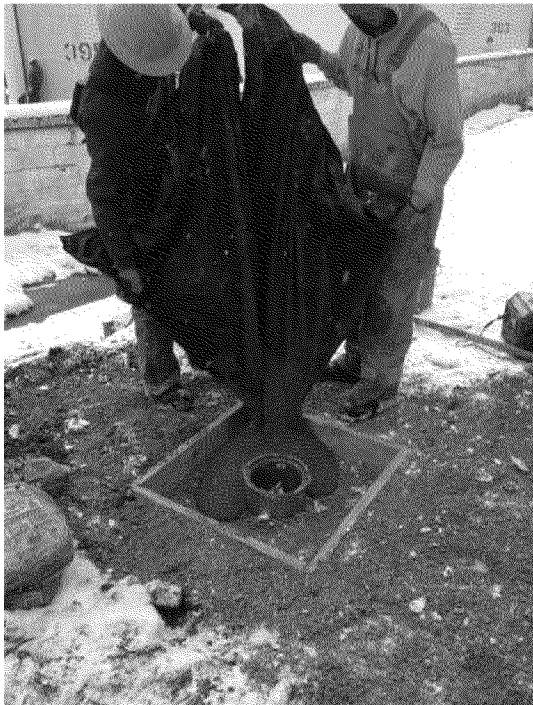
Photo No. IMG_1212; Taken on 01/21/14 at 8:21 hours by START GN. Enviroprobe preparing to pour concrete pad for MW in roadway.

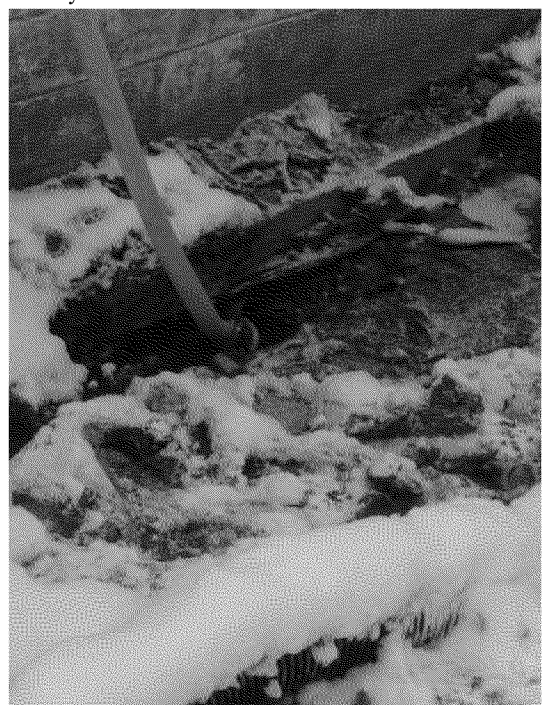
Photo No. IMG_1213; Taken on 01/22/14 at 8:28 hours by START GN. Vacuuming water from sump on east side of Tank containment wall.

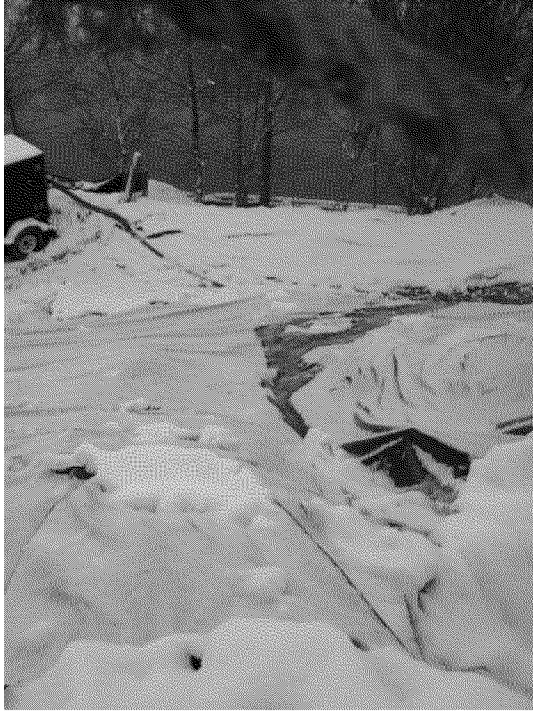
Photo No. IMG_1214; Taken on 01/22/14 at 15:04 hours by START GN. Water collection trench below culvert.

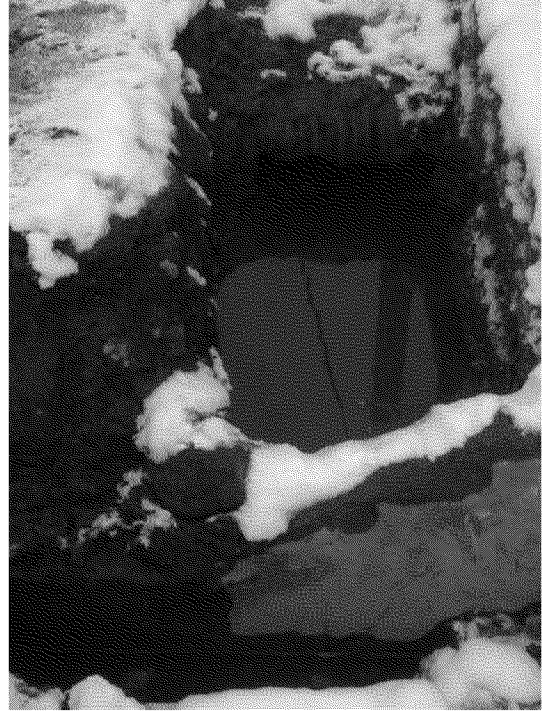
Photo No. IMG_1215; Taken on 01/22/14 at 15:05 hours by START GN. Accumulated water in sump dug at dilapidated culvert.

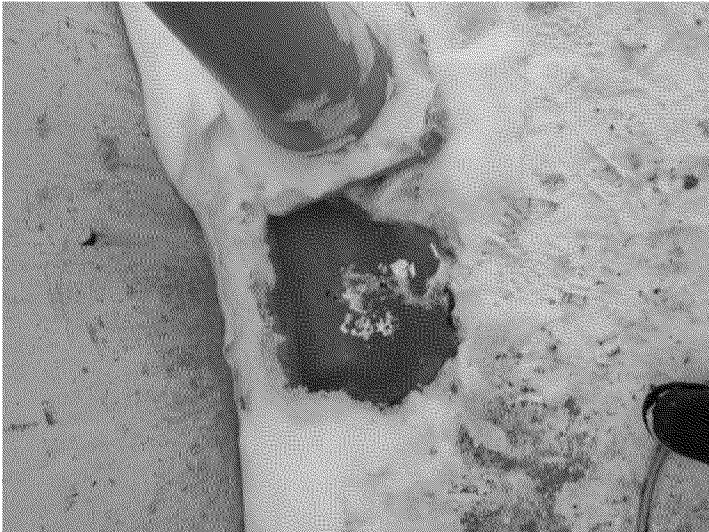
Photo No. IMG_1216; Taken on 01/22/14 at 15:05 hours by START GN. Frozen water and product in hole where release reportedly occurred.

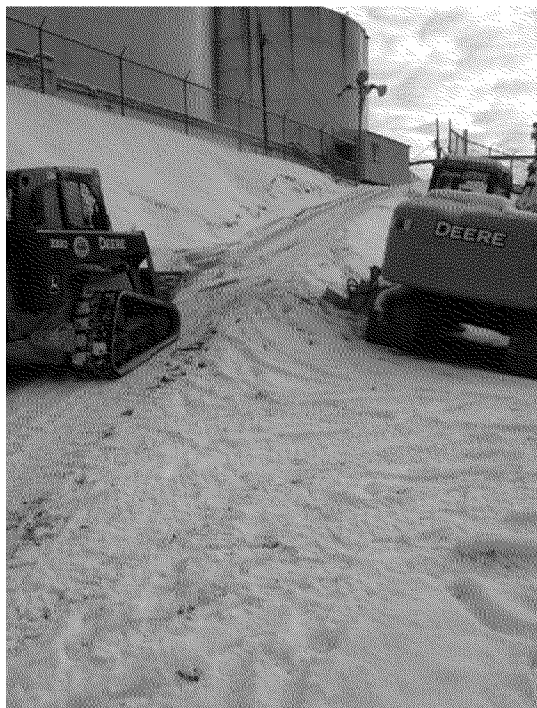
Photo No. IMG_1218; Taken on 01/22/14 at 15:29 hours by START GN. Water spraying from leak in hose caused by skid steer. Water in hose was pumped from water collection trench.

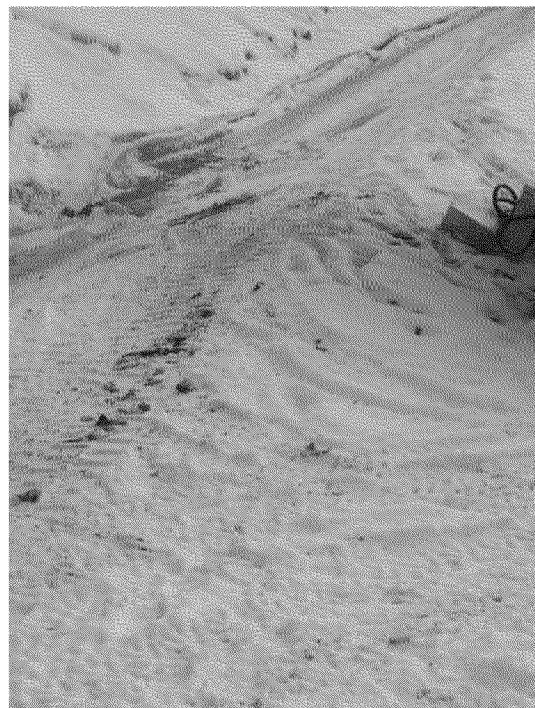
Photo No. IMG_1219; Taken on 01/22/14 at 8:21 hours by START GN. Water spraying from leak in hose caused by skid steer. Water in hose was pumped from water collection trench.

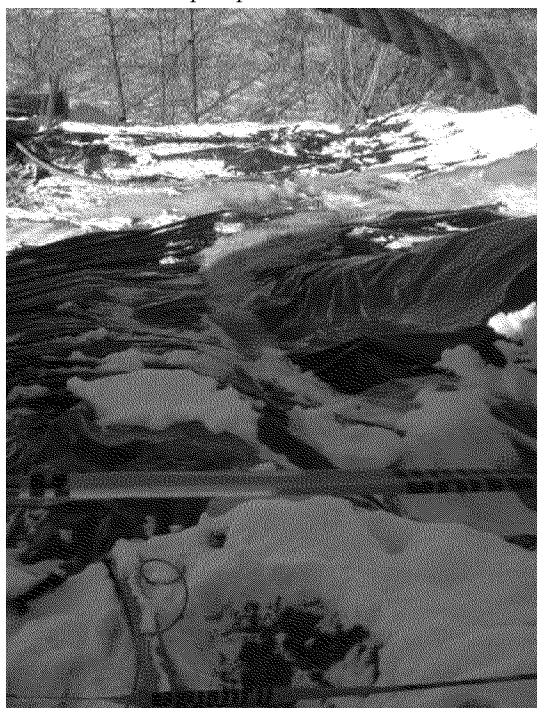
Photo No. IMG_1226; Taken on 01/24/14 at 11:42 hours by START GN. Ice covered water in collection trench

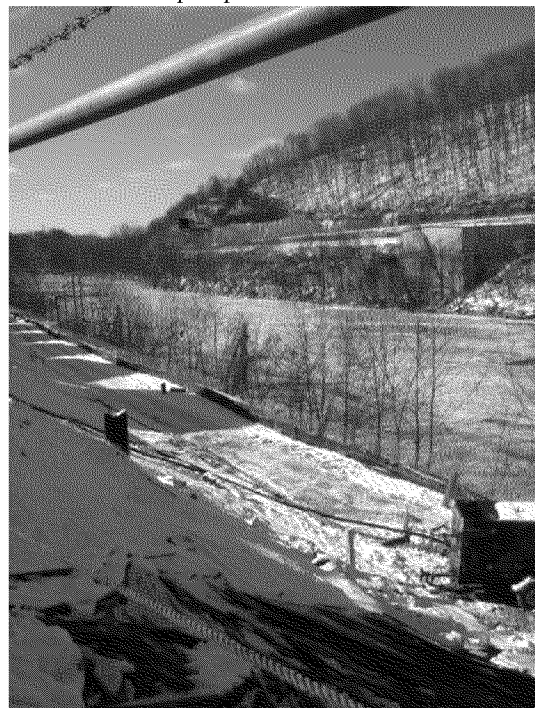
Photo No. IMG_1227; Taken on 01/24/14 at 14:32 hours by START GN. Ice cover on Elk River

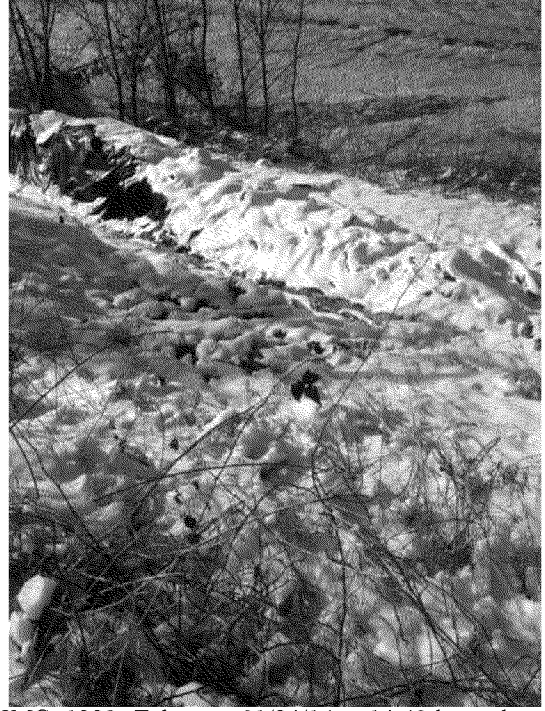
Photo No. IMG_1229; Taken on 01/24/14 at 14:40 hours by START GN. Water flowing in north end of the water containment trench.

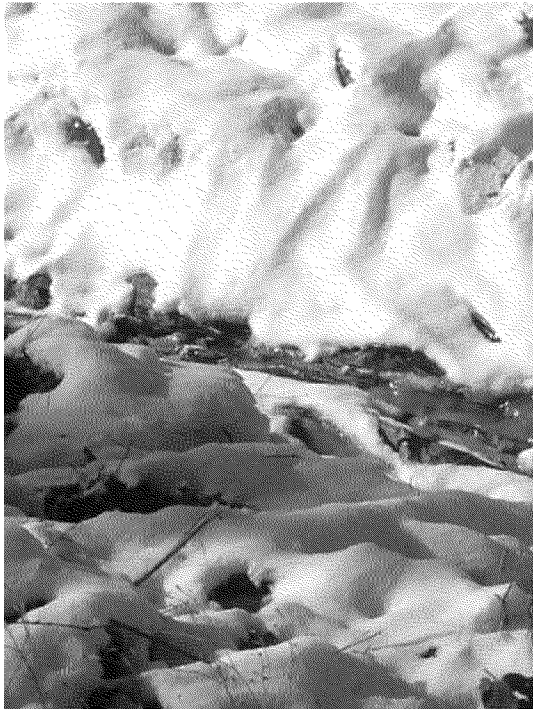
Photo No. IMG_1230; Taken on 01/24/14 at 14:57 hours by START GN. Water flowing in north end of the water containment trench.

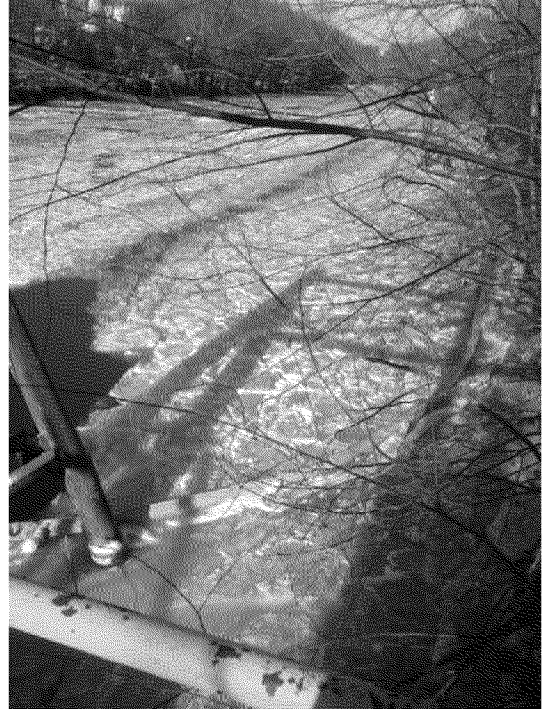
Photo No. IMG_1231; Taken on 01/24/14 at 0:00 hours by START GN. Ice cover on Elk River

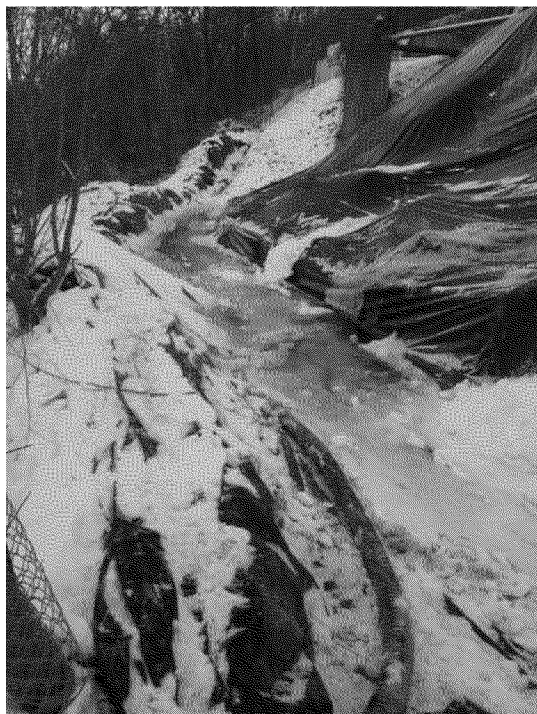
Photo No. IMG_1220; Taken on 01/23/14 at 8:22 hours by START GN. Ice covered water in collection trench

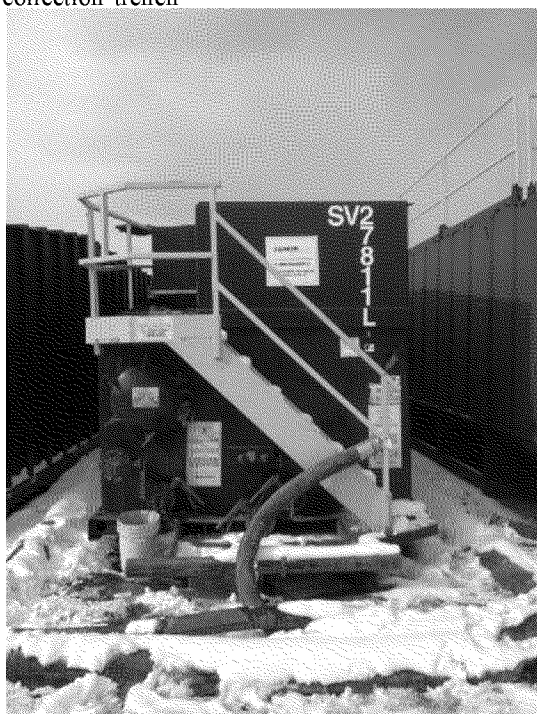
Photo No. IMG_1222; Taken on 01/23/14 at 11:53 hours by START GN. Baker Tank at Poca Blending where sample of MCHM/PPH mixture was collected.
